MSG 047 - FD06 MMT SUMMARY

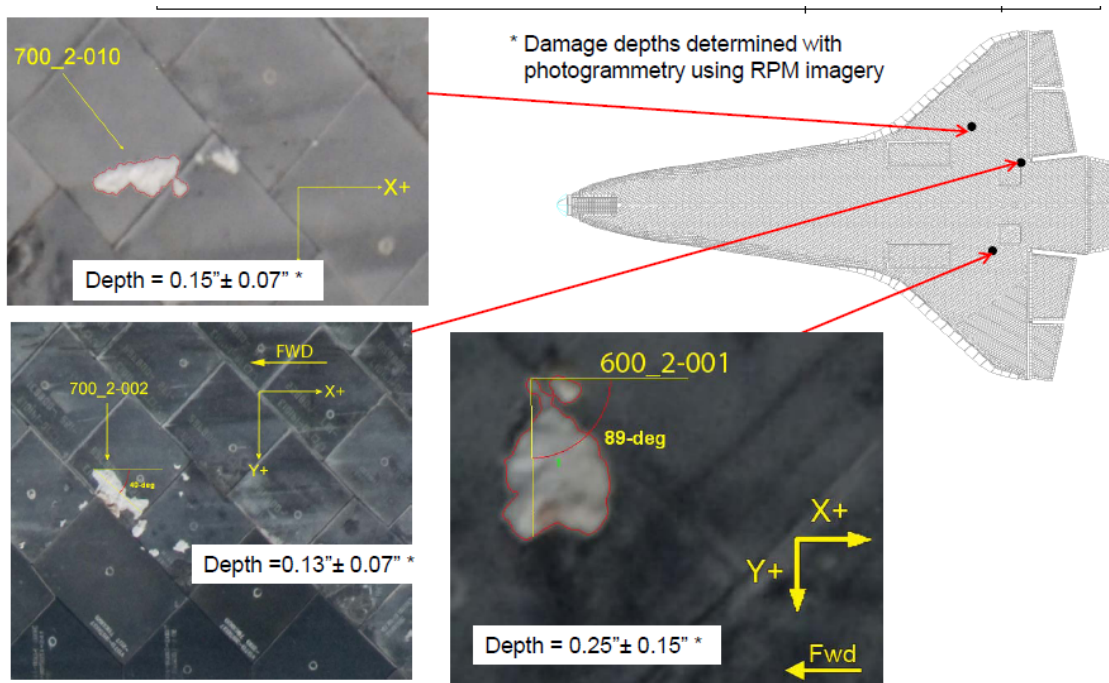
8
9 **Thermal Protection System** - The Damage Assessment Team provided their final
10 summary to the team and declared that the TPS is acceptable for entry. There is some
11 minor tile damage in the vicinity of the Boundary Layer Transition DTO protuberance tile, but
12 a thorough investigation has determined that there will not be any adverse interaction
13 between the damaged tile and the DTO. A comprehensive analysis also shows that a
14 protruding FRSI plug on the starboard OMS pod is not a concern.

Figure 1. Lower surface damage sites

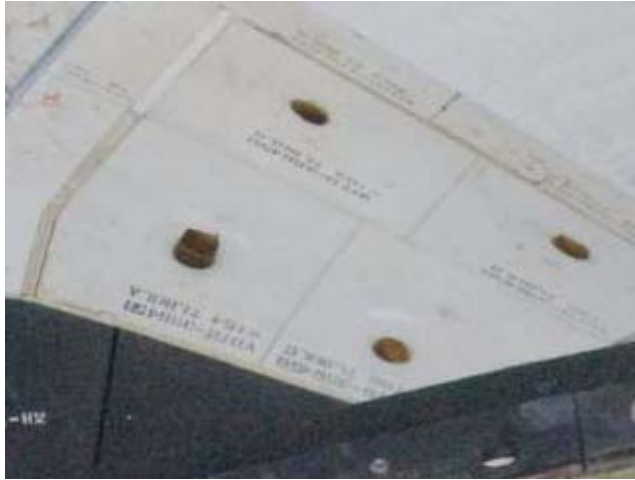
Figure 2. Protruding FRSI plug
